PHOTOGRAPHIC INTELLIGENCE REPORT

MUNITIONS STORAGE SITE I
NEAR HENG-YANG, CHINA

CIA/PIR 63045

DATE APRIL 1966

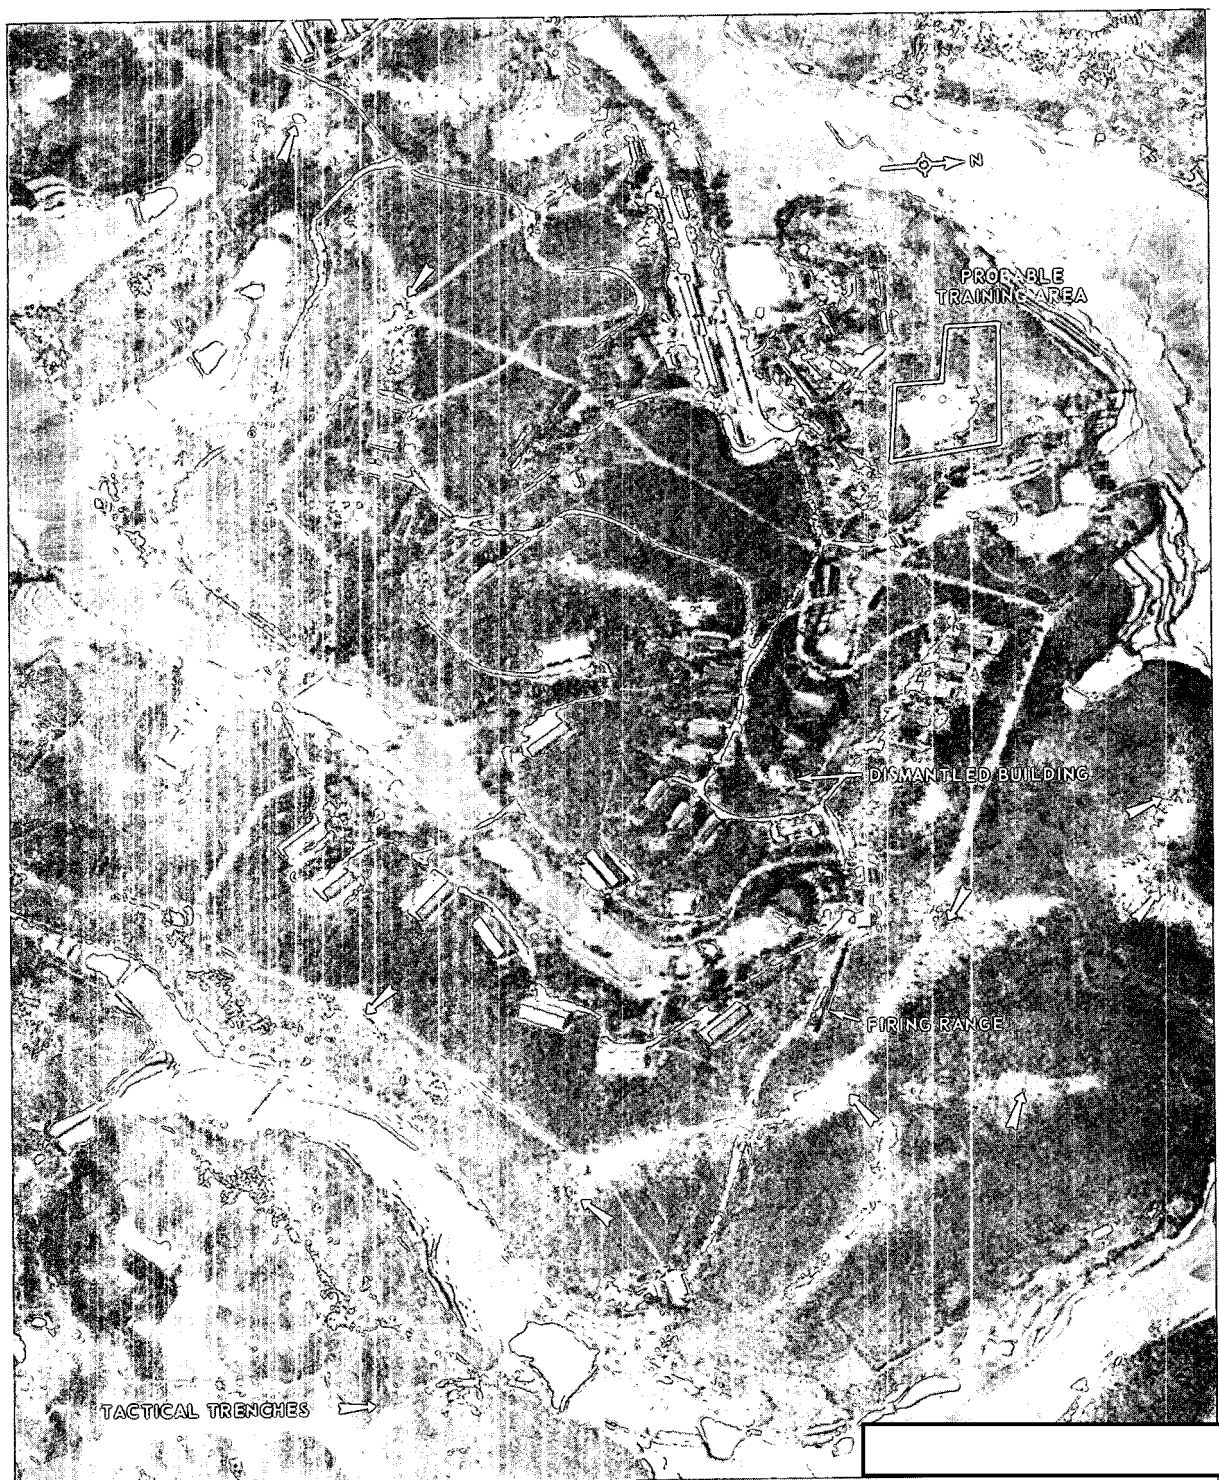
FIGURE 2. MUNITIONS STORAGE SITE 1 NEAR HENG-YANG, CHINA.

The probable weapons testing facility (Figure 3) consists of a firing range (Figure 2), a shop-type building with a monitor roof, a probable administration/laboratory building and 4 additional support buildings. One of the support buildings was in the process of being dismantled in November 1965 (Figure 2). This same building appeared intact on photography of May 1965.

The storage facilities are secured by a double fence. A single fence separately secures the housing and administration area. Guard-houses/checkpoints are located at the 6 entrances indicated in Figure 3. Guard posts, consisting of either pillboxes or small buildings, are located at high points around the perimeter and within the storage area (Figure 3). Tactical trenches are visible at strategic points outside the site perimeter (Figure 2). Trails connect the outer guard posts and tactical trench areas.

Facilities in the housing and administration area include 2 administration buildings, 3 barracks, 1 messhall, 1 vehicle maintenance building with 2 associated underground garages, a probable outdoor training area (Figure 2) and 20 additional support buildings. The 7 buildings located outside the east entrance probably provide housing and administration for the outer perimeter security forces.

The probable outdoor training area consists of a rectangular cleared area with what appears to be bleachers set up in one corner, a foxhole at one end of a cleared strip and an unusual facility which is probably a combination pillbox-automatic weapons position training unit.
